Defect detection in silicon charged particle detectors with a short-wave infrared (SWIR) camera

In order to be awarded the Master's Degree in
Physics Engineering

Master thesis submitted under the supervision of
Pr. Nicolas Pauly

Interuniversity Institute for High Energies (IIHE)

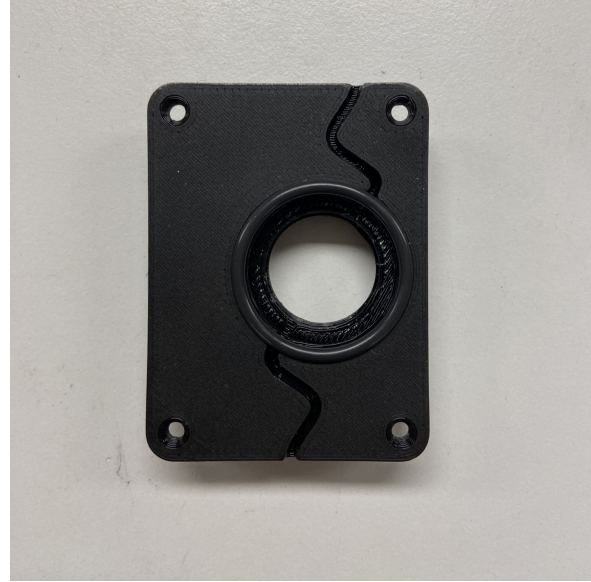
Figure 2.8: Top view of a filter cap mounted on a heatsink.

Figure 2.9: Bottom view of a filter cap with its O-ring.

These parts were designed to hold the narrow-band filters in front of the LEDs and ensure proper sealing to block unwanted photons (i.e., photons with undesired wavelengths) emitted by the LEDs. The caps are designed to be mounted directly onto the LED heatsinks. Figures 2.8 and 2.9 show top and bottom views of these components.

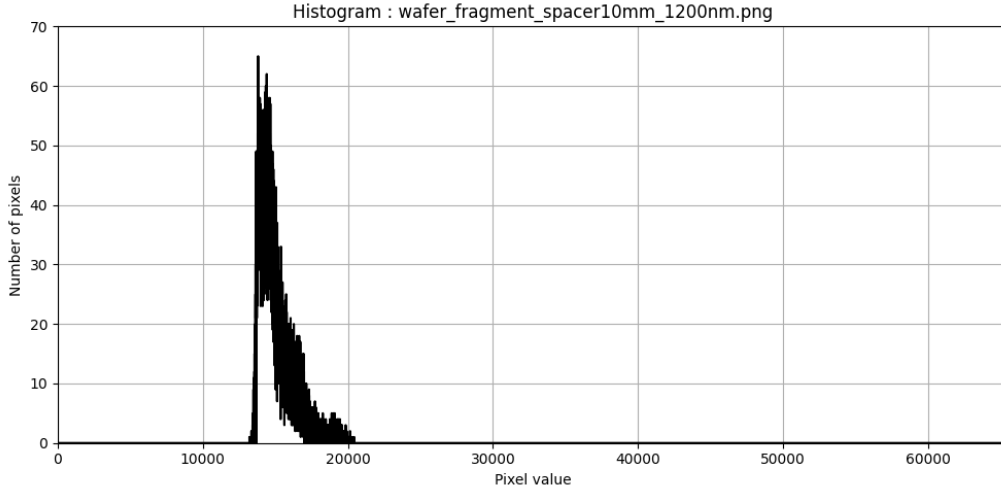
Figure 3.1: Histogram of the unprocessed+ IR image wafer_fragment_spacer10mm_1200nm.png. The corresponding image is given in Figure 3.2a.

The manual method allows the optimal range to be chosen manually, generally starting slightly above the lowest pixel value (to discriminate noisy background pixels) and, if necessary, saturating isolated high pixel values. This method yields better results but is time-consuming,

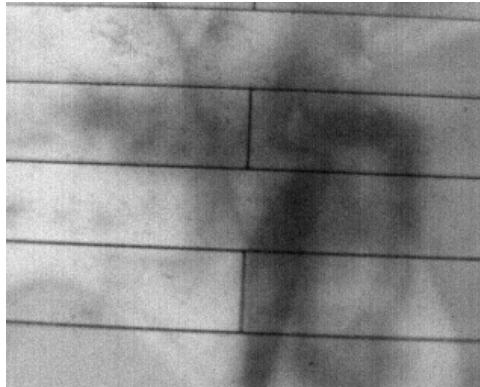
Figure 3.12: EL image of the scratched solar cell on the metallic backside, forward biased at 70mA, acquired with a 10mm spacer.

The pattern appearing bright in transmission (see Figure 3.6) appears dark in the EL image. The scratched backplane does not conduct current effectively in this area, leading to reduced EL emission.

These observations indicate that the EL technique allows detection of backplane defects.

Using the scratched solar cell, the device was forward biased and supplied with a current of 70 mA. The result of this experiment is shown in Figure 3.12.

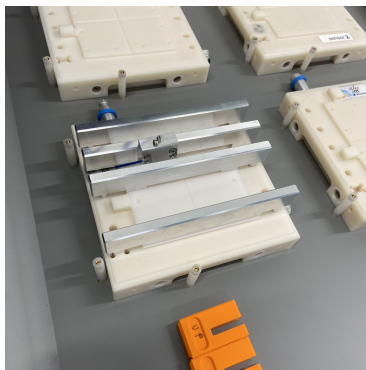
The construction of the 2S modules relies on manual jig-based assembly techniques, with robotic assistance for glueing and wirebonding. The first step in the assembly line involves glueing the Kapton isolators and high-voltage (HV) tails onto the sensors. The sensor is placed on a jig that holds it in a fixed position using a vacuum system. This jig is illustrated in Figure 1a. Metallic bars ensure that the Kapton is glued in the correct positions. This step is followed by wirebonding and encapsulation.

(a) Kapton jig.

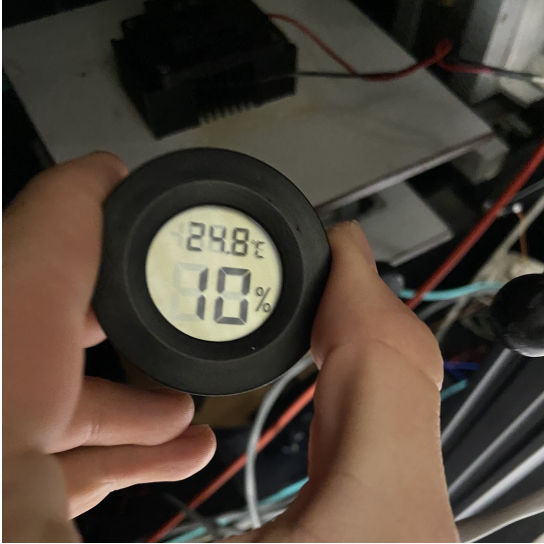
(a) Relative humidity measurement inside the light-isolated cabinet.
